CHARLES BUELL INSPECTIONS, Inc.

BUILDING INSPECTION REPORT

7491 Erehwon St, Seattle, WA 98155

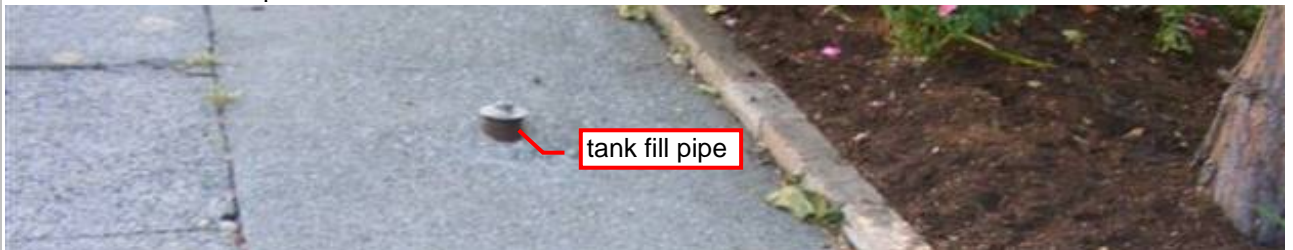
The fill pipe for the oil tank represents a trip hazard in the driveway. I recommend consulting with heating contractor as to best options for correction.

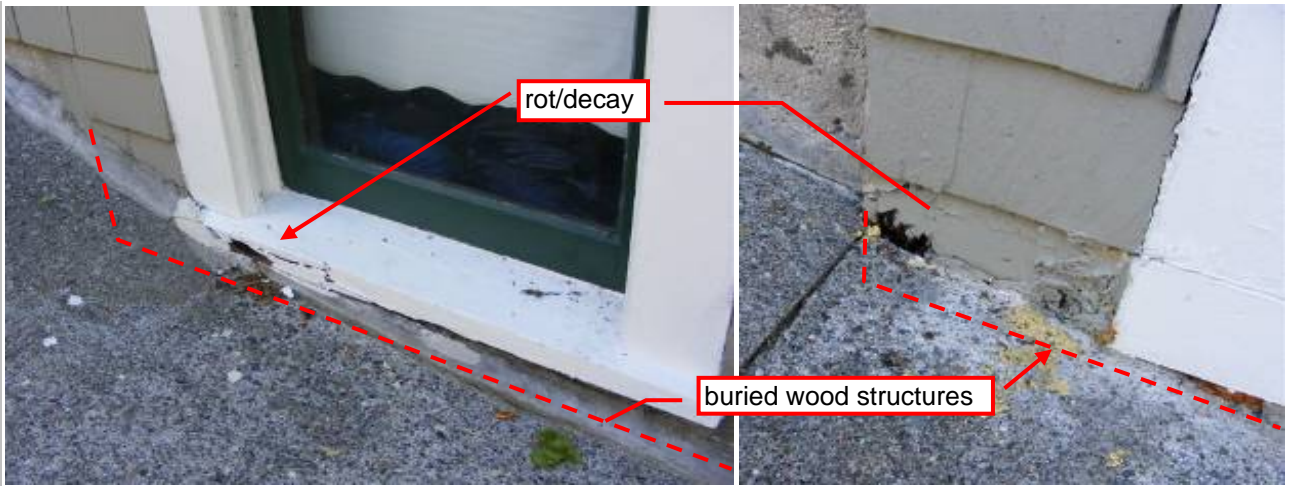
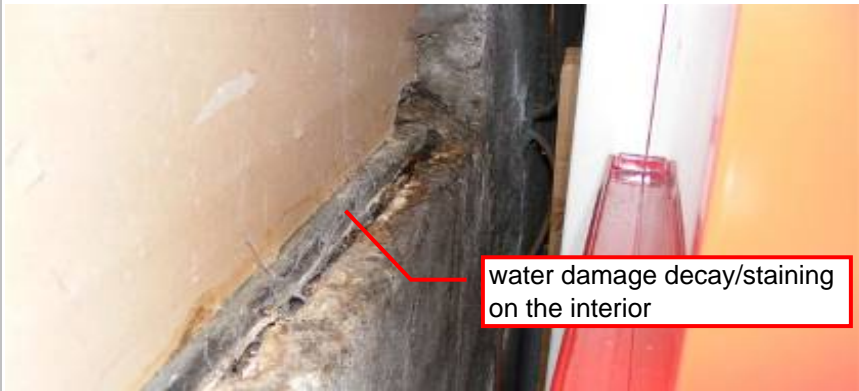
It is evident on both the exterior and the interior (along the North side of the home) that water has been getting into the wall and siding for some time. I recommend that the wall be opened up on the inside to determine the extent of damage and that all damaged wood be properly repaired/replaced as necessary by a licensed general contractor. I recommend that these areas that are too close to the finish grade of the driveway be given proper protection from water damage and that wood structures at finish grade be changed to pressure treated wood and that the exterior be properly flashed to prevent damage to wall and siding structures.

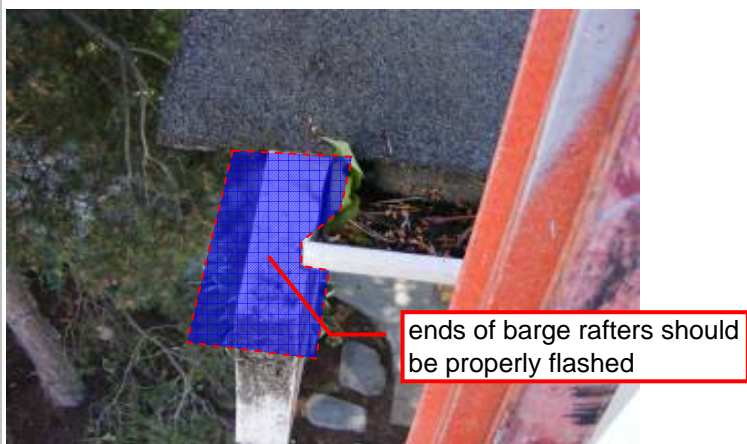
The outer rafter on the overhang of a gable roof is called a "Barge" rafter. The ends of these rafters often protrude past the edge of the roof and gutters. The top edge of these boards should be protected by roofing materials or flashing to prevent moisture damage to the ends of the rafters. This repair can be done by a licensed roofing contractor or knowledgeable homeowner/handyman. All decayed wood should be properly removed/repared as necessary.

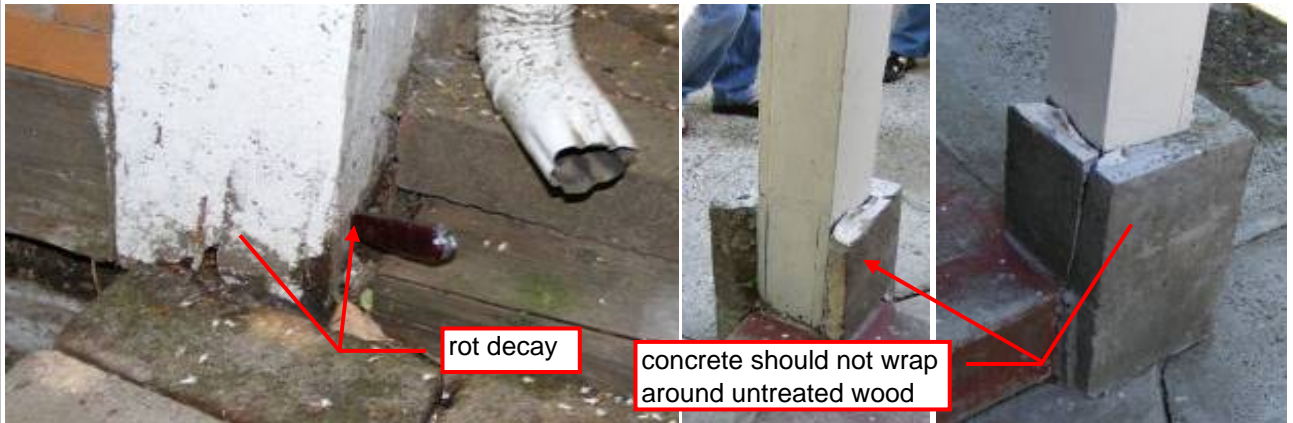
#2 The three support posts of the West Extension (former porch) are vulnerable to decay at the base and the one at the SW corner has extensive rot in the base and no longer adequately supports the structure. This decay is most likely the long term result of the downspout water dumping in this area. I recommend factoring replacement of all three of these posts with pressure treated support posts and that proper attachment at the base of the posts be provided. The current wrapping of the untreated wood post at the NW corner can lead to hidden damage and damage should be anticipated. I recommend proper repairs by licensed general contractor.

The three support posts of the West Extension (former porch) are vulnerable to decay at the base and the one at the SW corner has extensive rot in the base and no longer adequately supports the structure. This decay is most likely the long term result of the downspout water dumping in this area. I recommend factoring replacement of all three of these posts with pressure treated support posts and that proper attachment at the base of the posts be provided. The current wrapping of the untreated wood post at the NW corner can lead to hidden damage and damage should be anticipated. I recommend proper repairs by licensed general contractor.

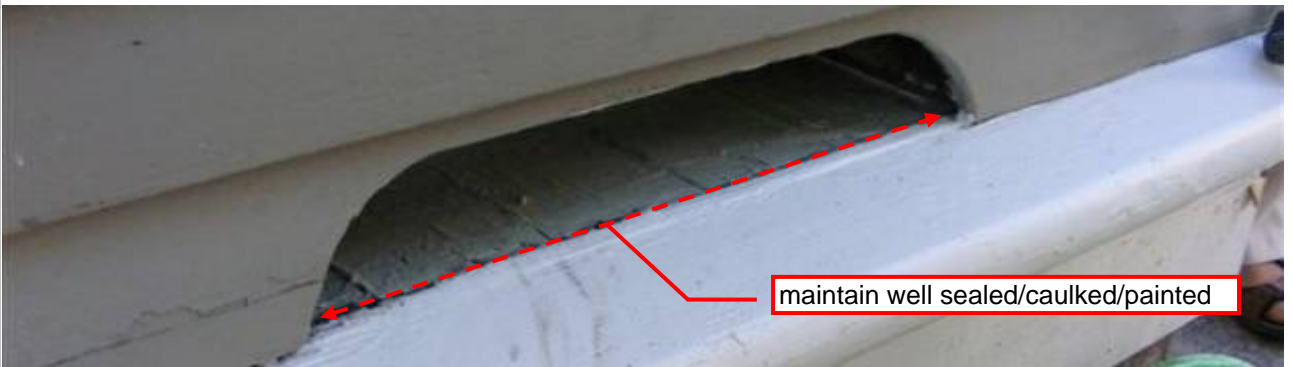
At the East porch there is a run-off opening that could lead to water getting into the support structures. There is evidence in the basement of water penetration in this area even though at the time of inspection this area tested negative for moisture by moisture meter. I recommend keeping these gaps well caulked and sealed. This porch is out of the prevailing winds/direction of weather and considerable water on the porch is not likely except when cleaning. A good improvement would be for the deck surface to extend past the trim. This improvement should be considered when the deck surface is upgraded.

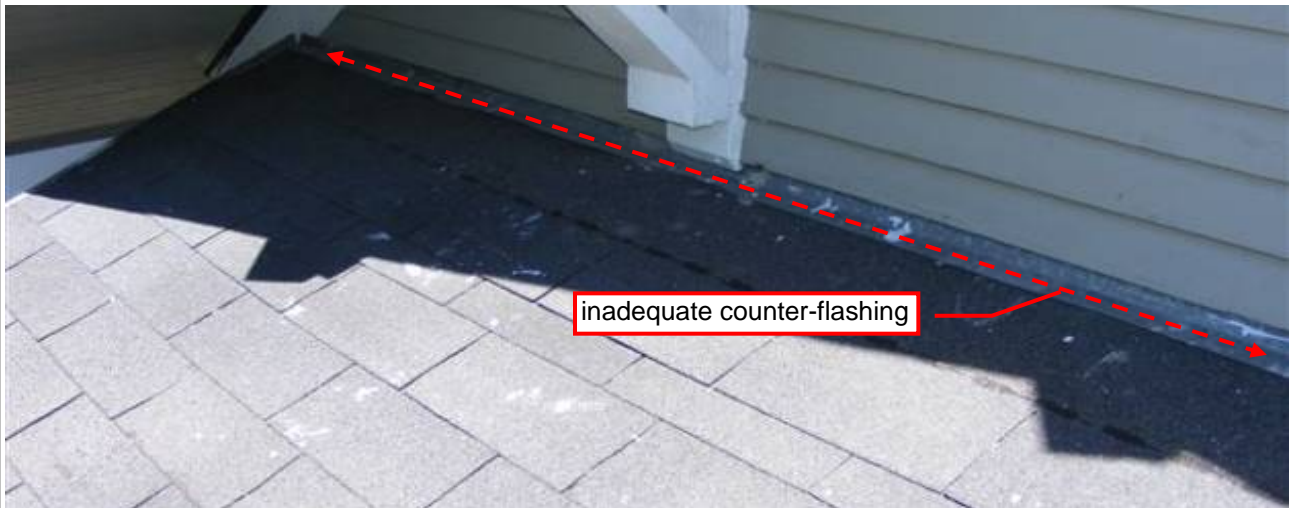
#3 The roof surface of the West Extension has reached the end of its useful life and no longer adequately protects the home from damage from the elements. I recommend replacement of the roof by a licensed roofing contractor in the near future----prior to the next rainy season. Besides the ageing of the surface there are poor flashing details that can lead to water infiltration of the house wall and the ceiling below.
Replacement of the roof should include installation of eave and rake flashings.

The roof surface of the West Extension has reached the end of its useful life and no longer adequately protects the home from damage from the elements. I recommend replacement of the roof by a licensed roofing contractor in the near future---prior to the next rainy season. Besides the ageing of the surface there are poor flashing details that can lead to water infiltration of the house wall and the ceiling below.

Replacement of the roof should include installation of eave and rake flashings.

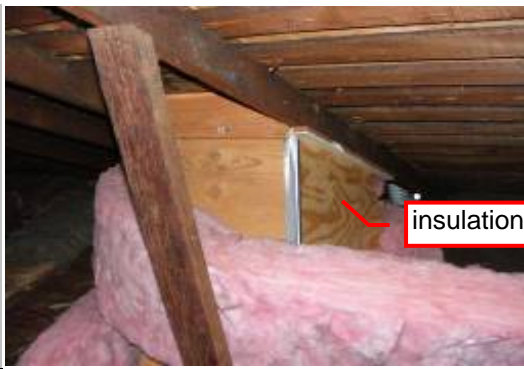
The skylight well visible in the attic is missing its insulation. I recommend proper insulating of the skylight well (this will help reduce condensation in the well). This can be done by homeowner/handyman or perhaps in conjunction with upgrading of the insulation in the attic space.

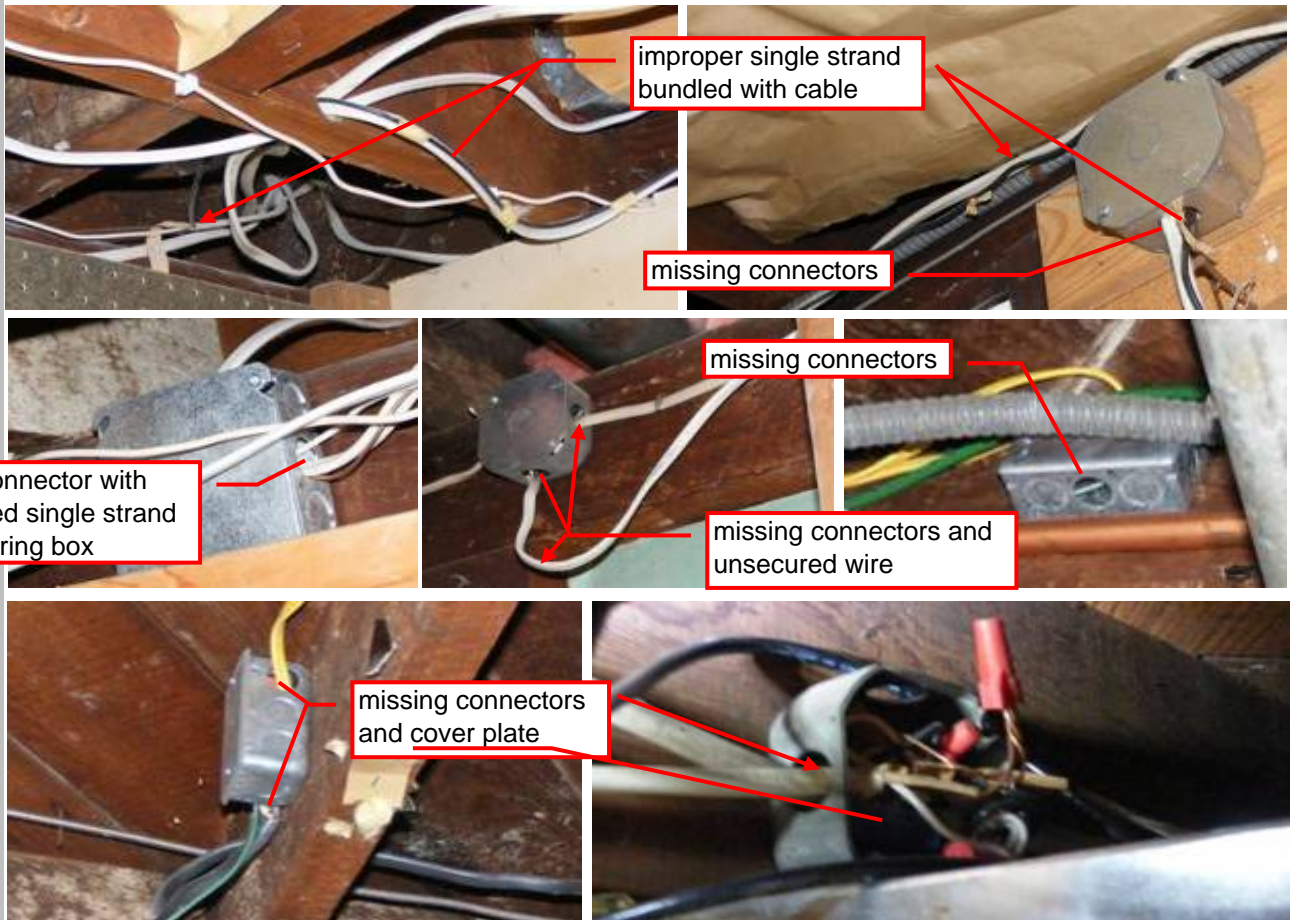
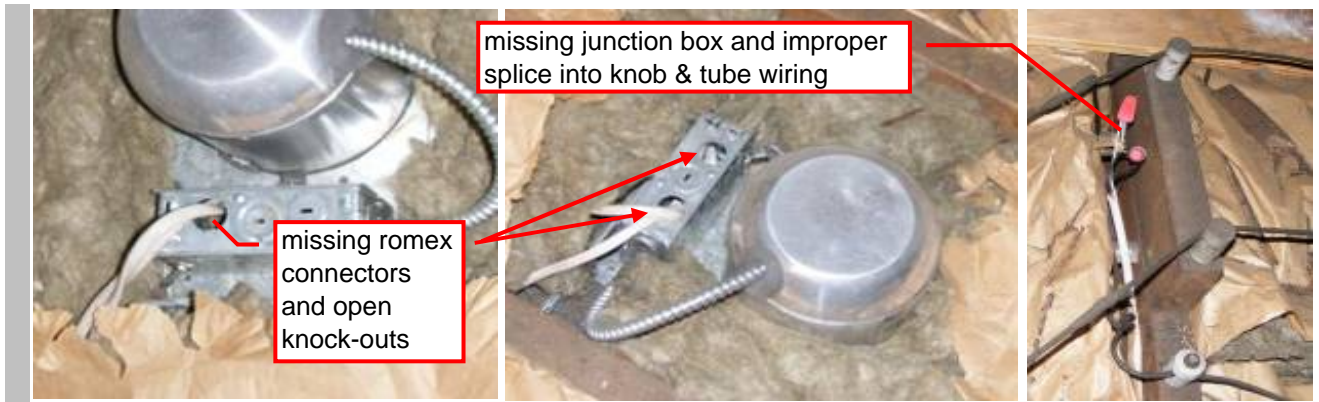
#4 There has been extensive wiring done in the basement and the attic (perhaps in the walls as well) that show "less-than-professional" installation. There are a very large number of junction boxes with wires installed without proper termination connectors (romex connectors). I recommend a through evaluation/repair by a licensed electrical contractor of all of these exposed junction boxes in the attic and basement. The additional wire run to provide a third leg for the West outside light (to provide switching of the light both in the basement and at the top of the stairs) is not proper and should be corrected by the licensed electrical contractor.

There has been extensive wiring in the basement and the attic (perhaps in the walls as well) that show "less-than-professional" installation. There are a very large number of junction boxes with wires installed without proper termination connectors (romex connectors). I recommend a thorough evaluation/repair by a licensed electrical contractor of all of these exposed junction boxes in the attic and basement. The additional wire run to provide a third leg for the West outside light (to provide switching of the light both in the basement and at the top of the stairs) is not proper and should be corrected by the licensed electrical contractor.

missing junction box and improper splice into knob & tube wiring

missing romex connectors and open knock-outs

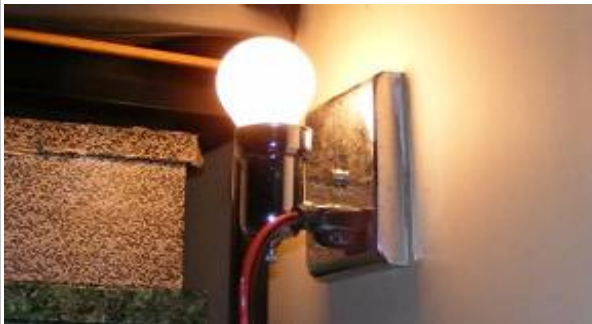
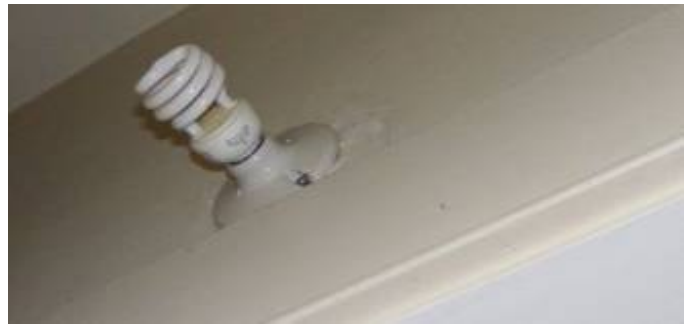
I recommend upgrading the exposed bulb type porcelain lamps in the closets and basement storage room to approved closet type fixtures by licensed electrical contractor when they are at the home making other repairs.

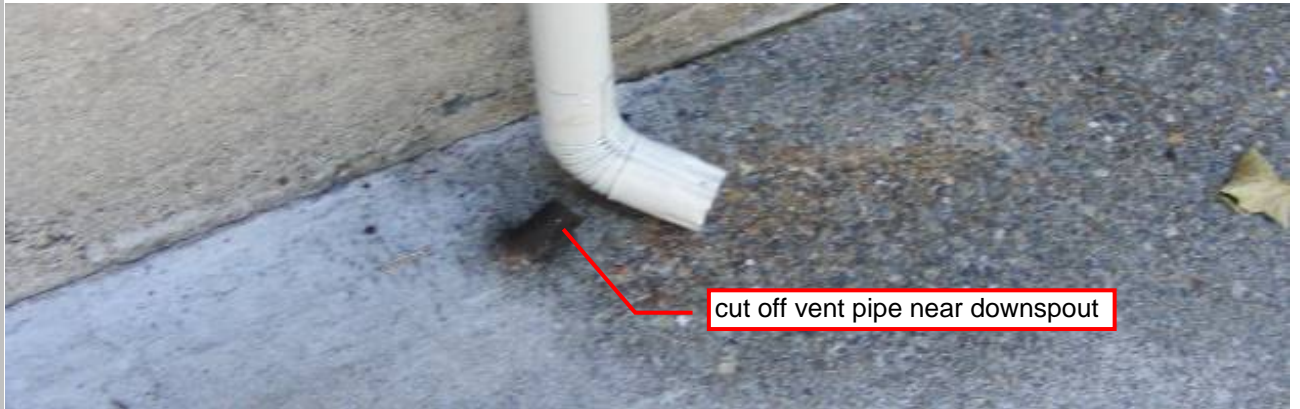
#8 The oil tank is apparently located under the driveway. The vent pipe appears to be cut off at the surface of the driveway and is likely to allow surface water into the tank. I recommend further evaluation/repairs by licensed heating contractor. I also recommend asking the heating contractor if there are any associated issues posed by its being located under the driveway.

The oil tank is apparently located under the driveway. The vent pipe appears to be cut off at the surface of the driveway and is likely to allow surface water into the tank. I recommend further evaluation/repairs by licensed heating contractor. I also recommend asking the heating contractor if there are any associated issues posed by its being located under the driveway.

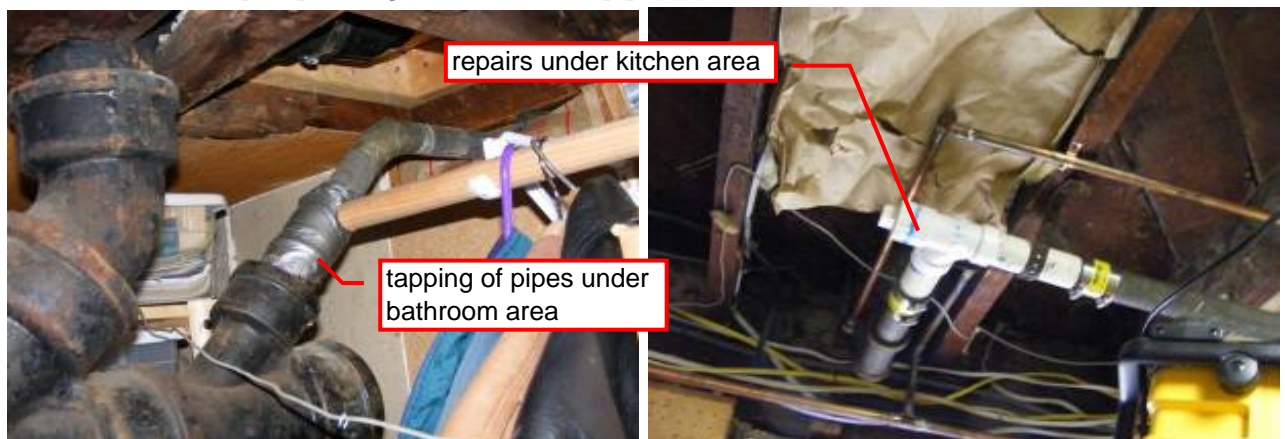
#10 Much of the drainage plumbing in the home is the older style galvanized pipe. This pipe is at the end of its expected life and typical corrosion at joints and pipes is evident throughout. There are some areas wrapped with duct tape. Attempts at cleaning these drains usually accelerates their demise, especially with the use of corrosive types of drain cleaning products. Corrosive types of drain cleaning products should never be used in metal drain lines. There are some Bio-Enzymatic types of cleaners that can be quite effective. I recommend factoring replacement of these older drains by a licensed plumber in the near future. The bathroom tub and sink drains drain very slow.

There is evidence of previous replacement of drain components.

There is evidence of past patching of leaks in drain pipes.

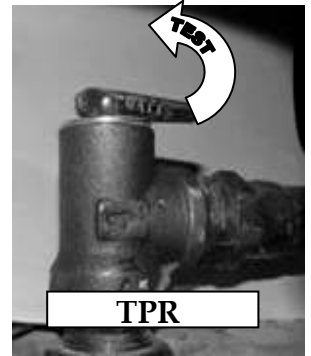
A temperature and pressure relief (TPR) valve is required on all water heaters to discharge any excessive pressure within the tank. A discharge pipe should be attached to the TPR valve and directed to a safe location away from body contact. Newer installations must be directed to the building exterior. Most manufacturers suggest that homeowners test the TPR valve at least once a year by lifting the lever to ensure the valve discharges properly. The picture to the right shows a typical top-of-tank type TPR Valve. They may also be found on the side of the heater on some models. This inspector does not test these valves due to the possibility that they may leak after testing. A leaking or inoperative TPR Valve should be replaced immediately by a licensed plumber.

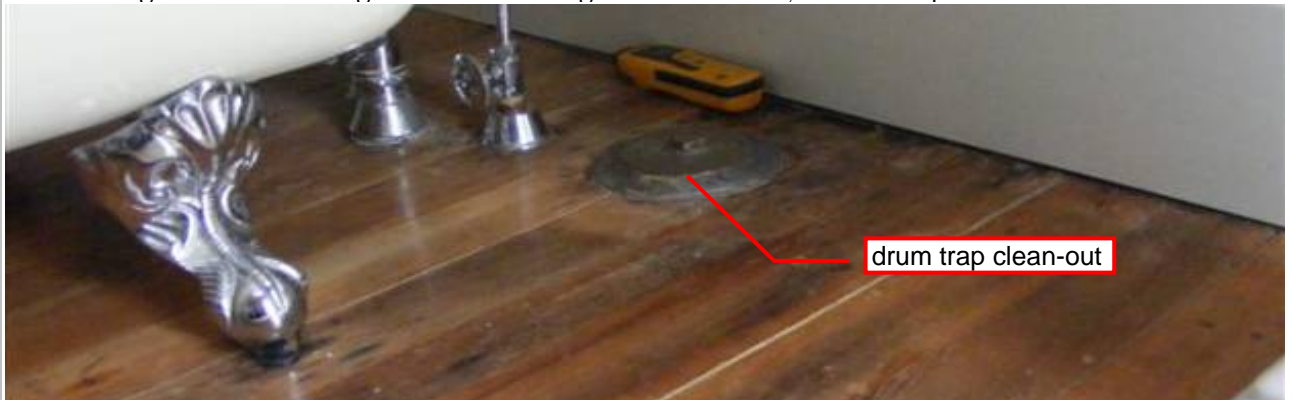
The tub appears to drain through the original drum type trap with it's clean-out cover showing in the bathroom floor next to the tub. This drum trap is past its expected life and clogging is very common. I recommend factoring replacement of this trap. It is likely that this is located behind the finished basement room ceiling and access through this finish ceiling will be necessary to make repairs.

Like the sink, the tub drainage is not satisfactory. See plumbing drainage section about recommendation for replacement of the old drain pipes.

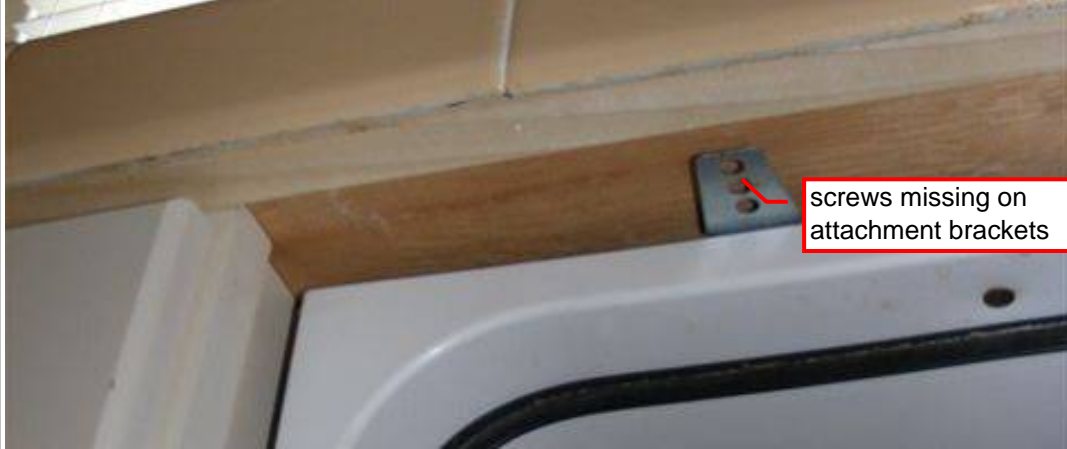
The dishwasher is not properly vented. I recommend that when a licensed plumber is at the home for other reasons a proper vent be installed for the dishwasher

The dishwasher is not properly attached to the underside of the countertop. I recommend proper attachment by licensed plumber or knowledgeable homeowner/handyman.
