CHARLES BUELL INSPECTIONS, Inc.

# BUILDING INSPECTION REPORT

## At the Corner of Fith and Vine

**120613NH 1146**

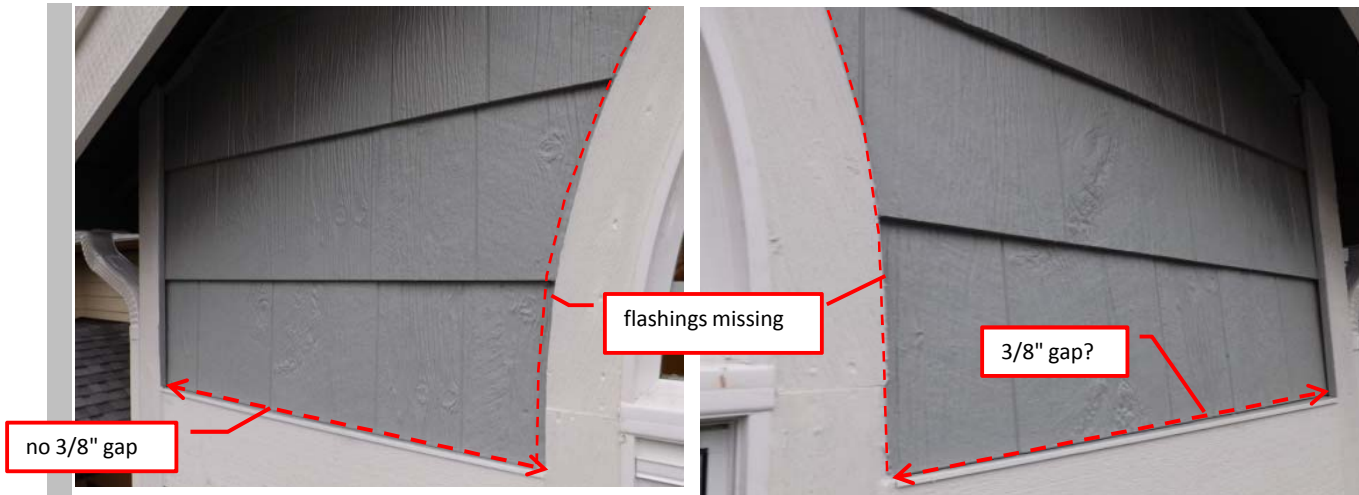
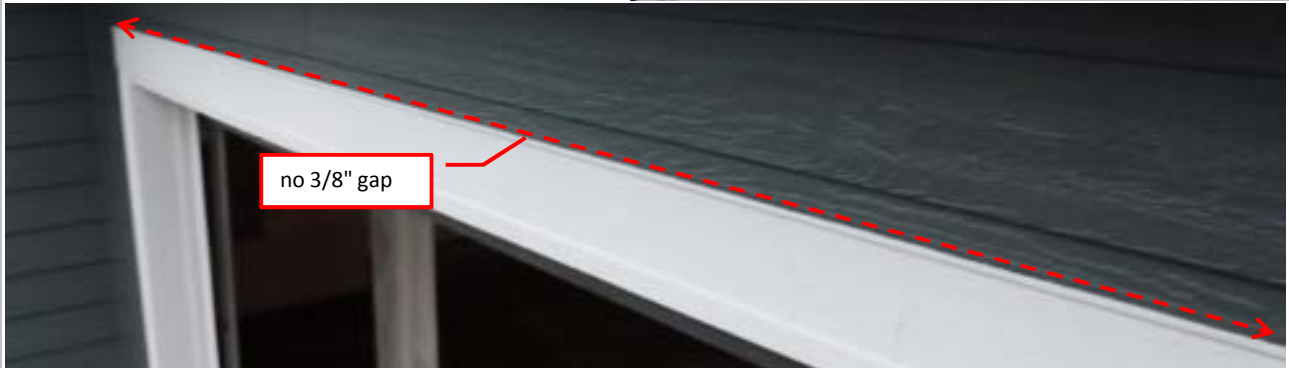
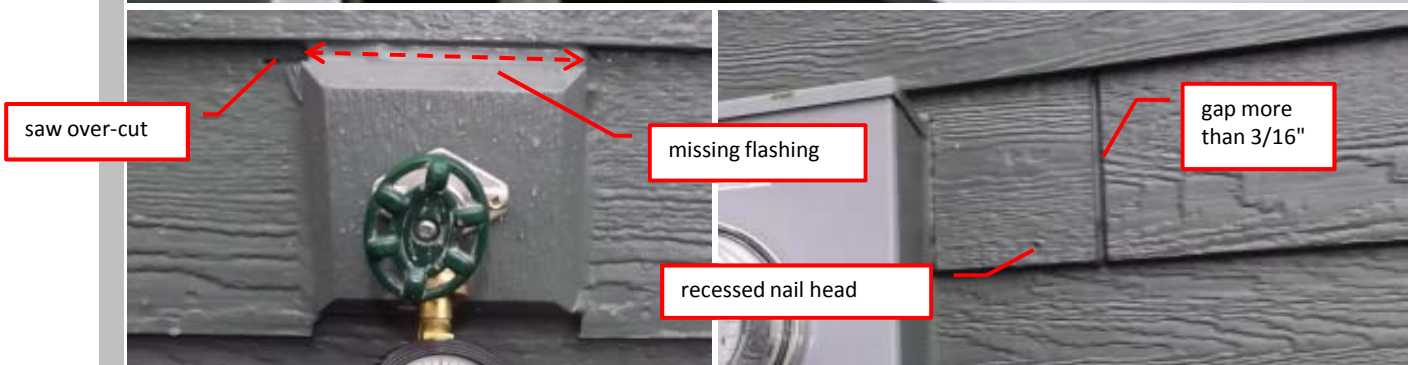
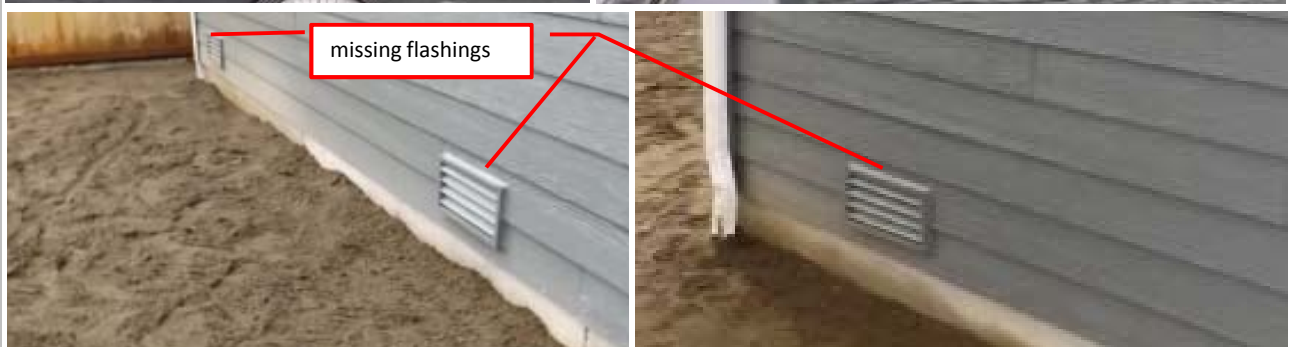
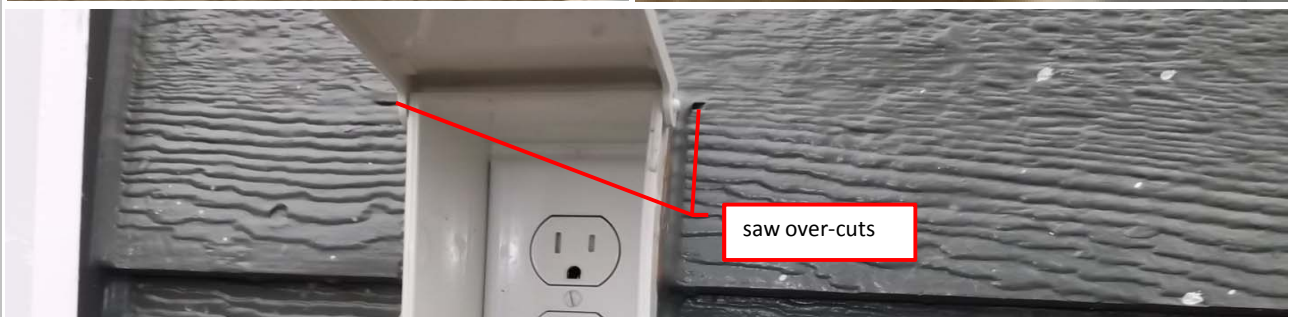
The LP (Louisiana Pacific) brand siding has a long history of difficulties and has been involved in class action law-suits in the past. The date this material was installed would generally be considered to be after the period of time usually associated with this material and it is possible that this material is a newer version of the material that had problems. It is very important to keep this material well painted/sealed to prevent moisture damage. I recommend annual monitoring of this siding for signs of decay and that it be re-inspected professionally every 3-5 years. These types of materials can hold up well if maintained and installed properly. While this entire installation seems well painted and caulked it is not installed according to published manufacturer's instructions.

Verification is recommended that it is in fact installed properly as there may be exceptions to the published recommendations. Some of the noted issues: Horizontal siding/flashings are caulked with no 3/8" gap, nails that have been over-driven have not been filled and sealed, gaps between butt joints are considerably wider than maximum 3/16" at many locations, saw over-cuts and there are many areas that are missing flashings (window trim on East side of home, outside faucet blocks, crawl space vents). I recommend bringing all of these issues to the attention of the builder and that they be addressed to your satisfaction.

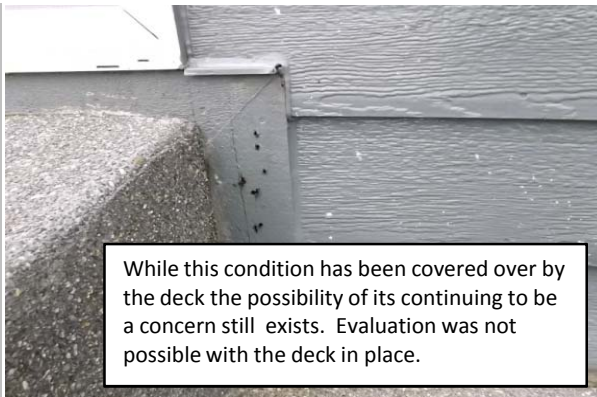
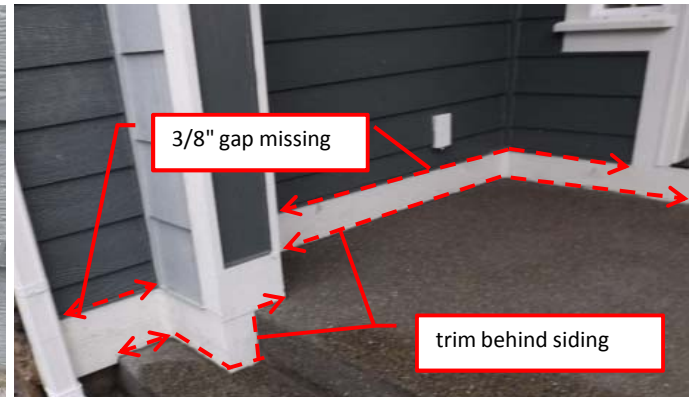
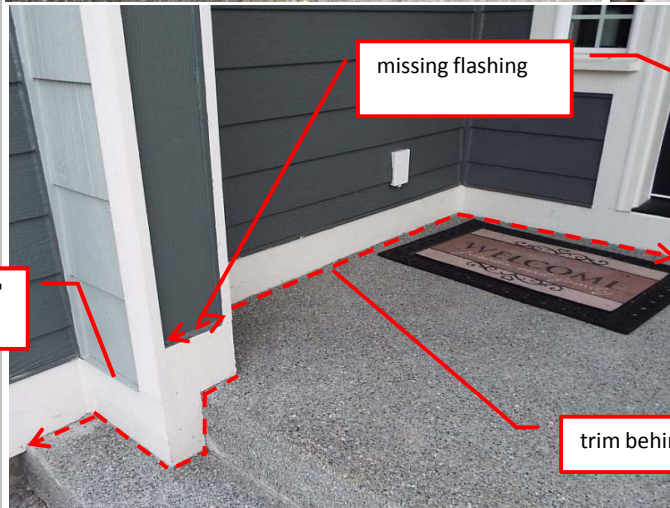
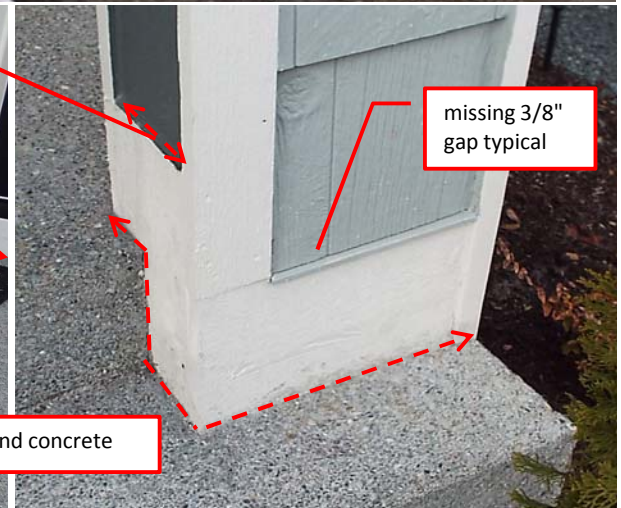
Builders often install decks over untreated trim components, in spite of the recommendations of the manufacturer. While damage to the structure from this installation is unlikely, I must still report the condition as less than ideal.

At the time of inspection hidden structures were not visible from interior spaces. The potential for hidden damage is always a possibility in this situation.

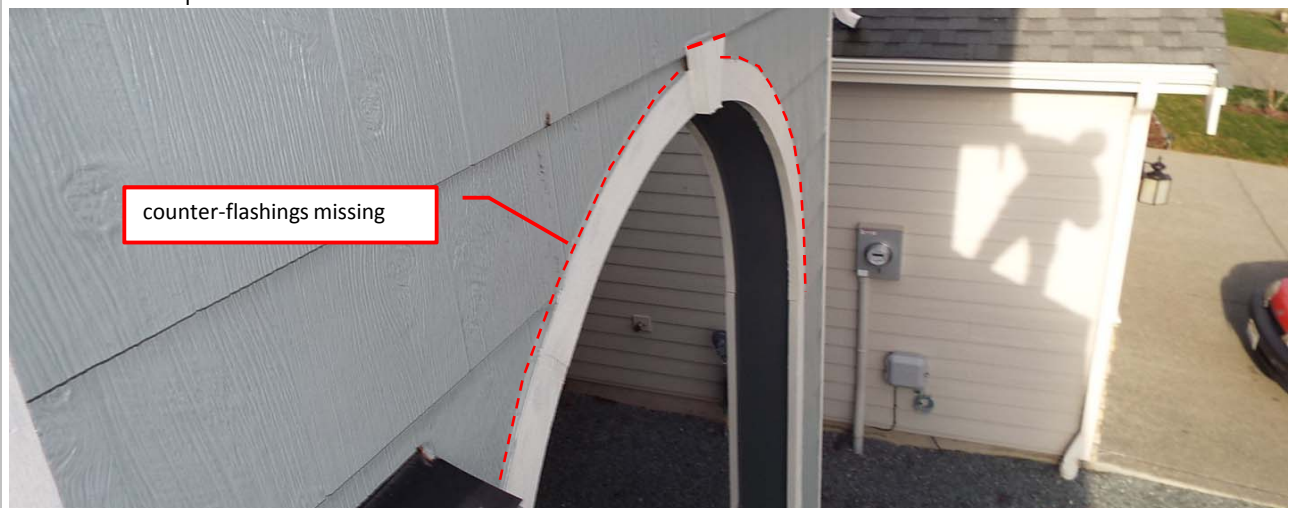
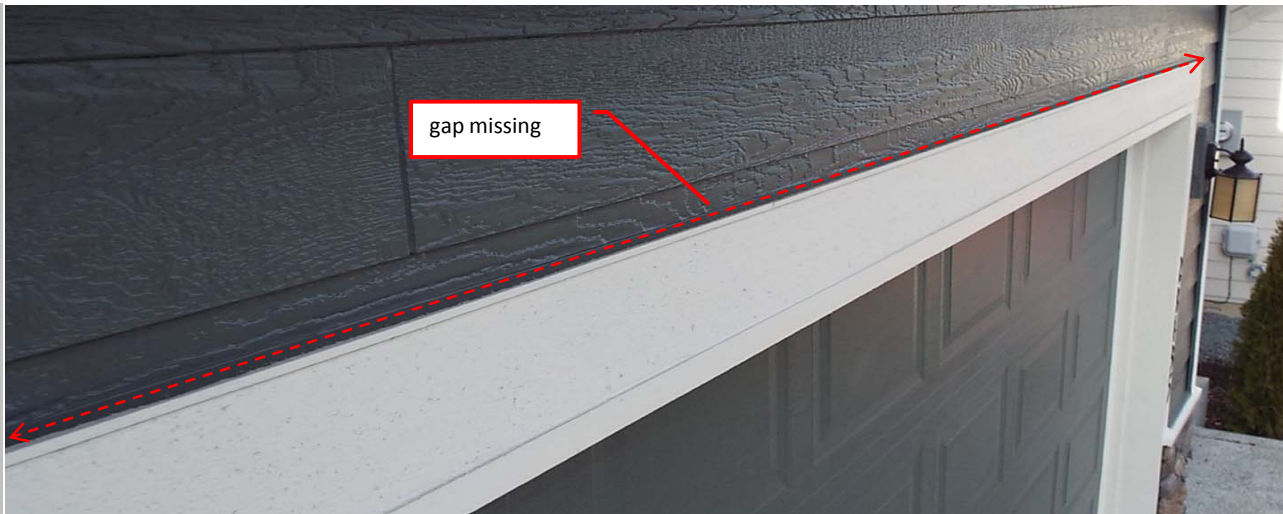
Some exterior trim components above windows and doors are missing proper metal counter-flashings. I recommend installation of proper flashings by a qualified siding contractor where deemed necessary. Locations well protected by roof overhangs usually do not need these counter-flashings.

Many of the windows have had trim installed around them in conjunction with the installation of the windows. Ideally the head trim around these windows should have been counter-flashed but have been caulked instead. Maintaining these areas well caulked and sealed is recommended or have proper flashings installed to reduce maintenance---at least on more exposed windows.

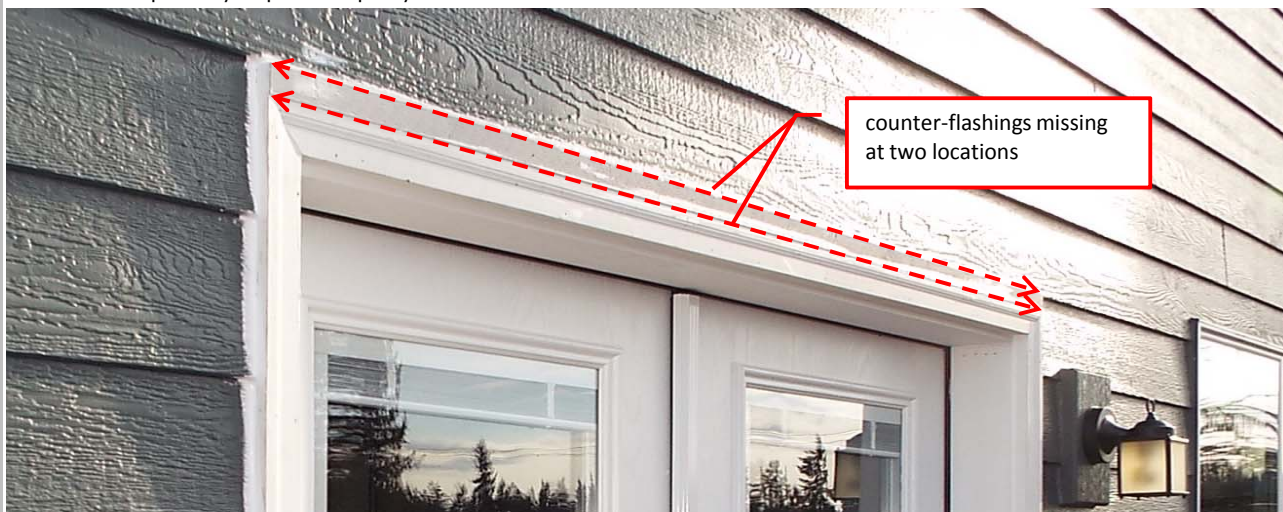
The new door at the West side of the home is not properly flashed at the top of the head jamb. I recommend evaluation/repairs by a qualified party.

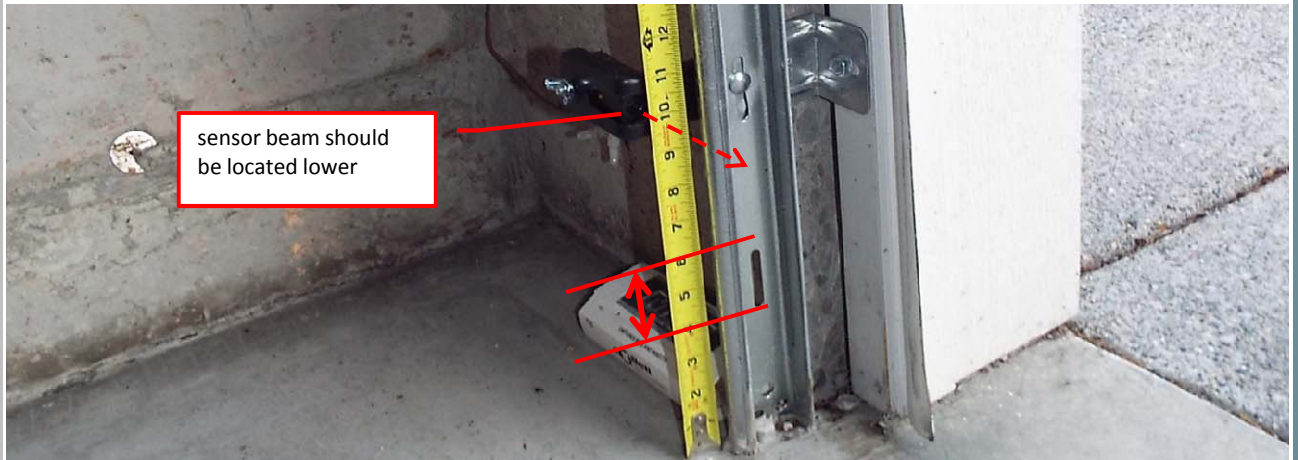
To prevent injury to children and pets the safety beams for garage doors should be located between 4-6" of the floor. I recommend for safety that the sensors on both of the overhead doors be properly located by a qualified garage door installation company.

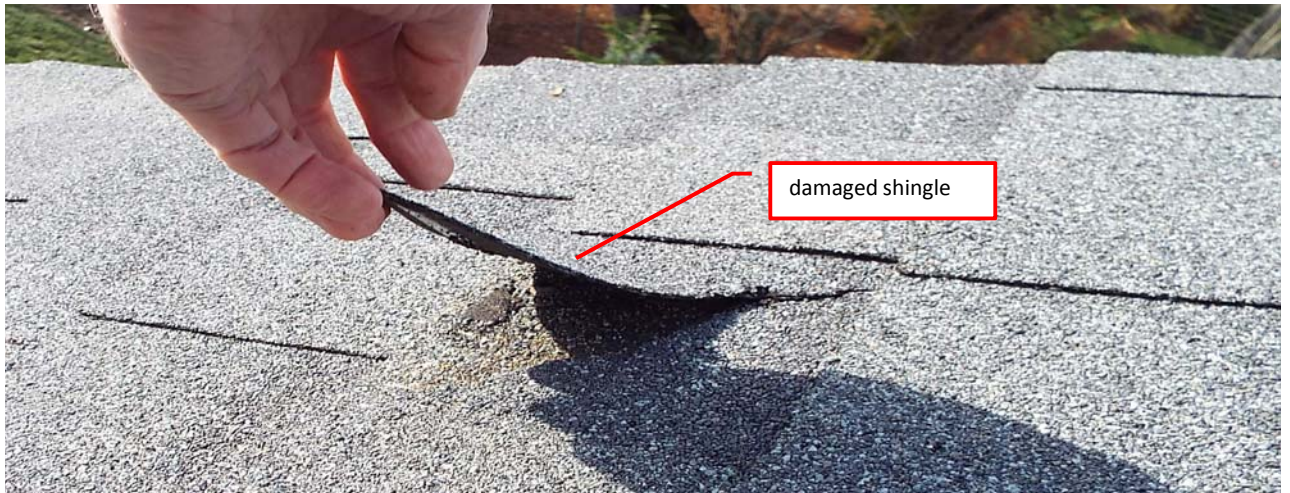
At the Upper NW corner of the roof there is some minor mechanical damage to a couple of the shingles. I recommend evaluation/repairs by a qualified party.

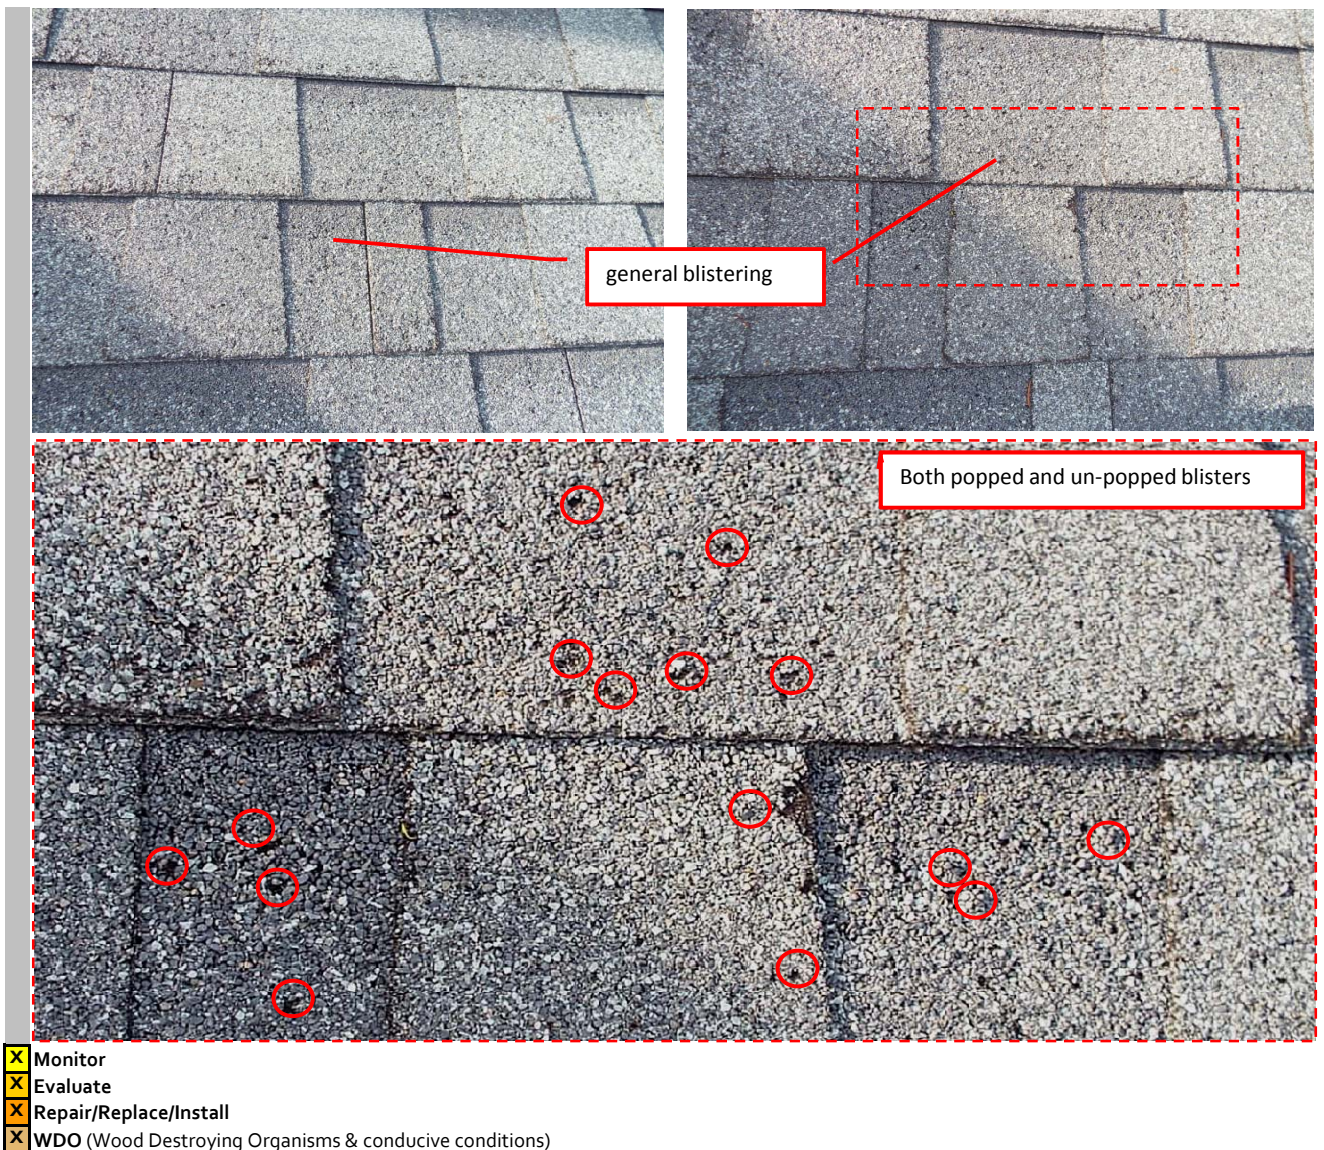
The condition of the roof may be premature failure of the roof surface consistent with factory defects or other causes. I am unable to determine if these are shingles that were part of any recall. I recommend a full evaluation of the roof by a qualified roofing contractor to determine how much longer the roof will be satisfactory and/or provide an estimate for repairs/replacement. There are a lot of opinions as to the cause of shingle blister, but I lean toward moisture/gases trapped within the shingles at the time of manufacture. This is consistent with the "randomness" of the issue on this roof as it appears primarily localized to the lower roof across the garage door openings.

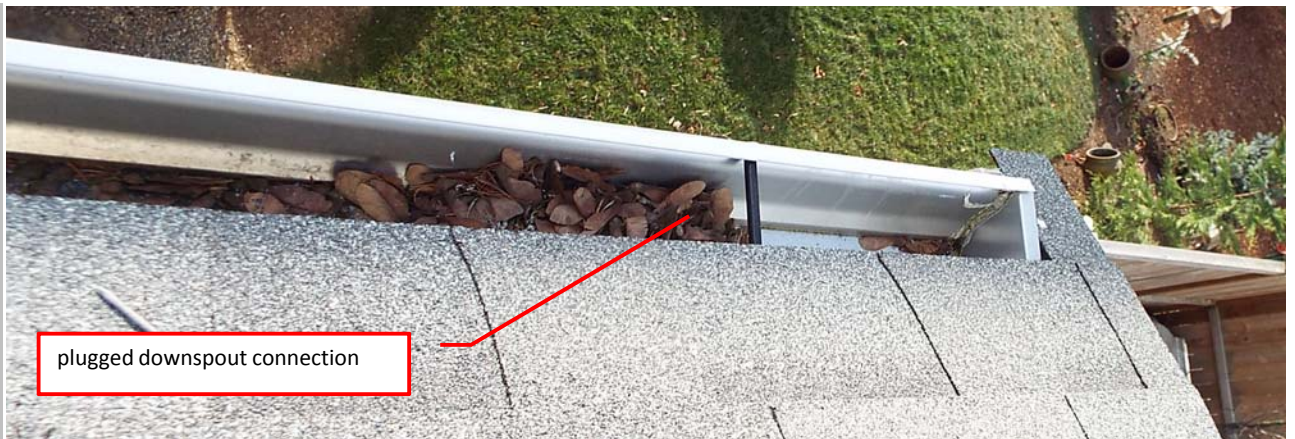
Some of the gutters need cleaning. I recommend professional cleaning of the gutters and downspouts and verification of proper function.

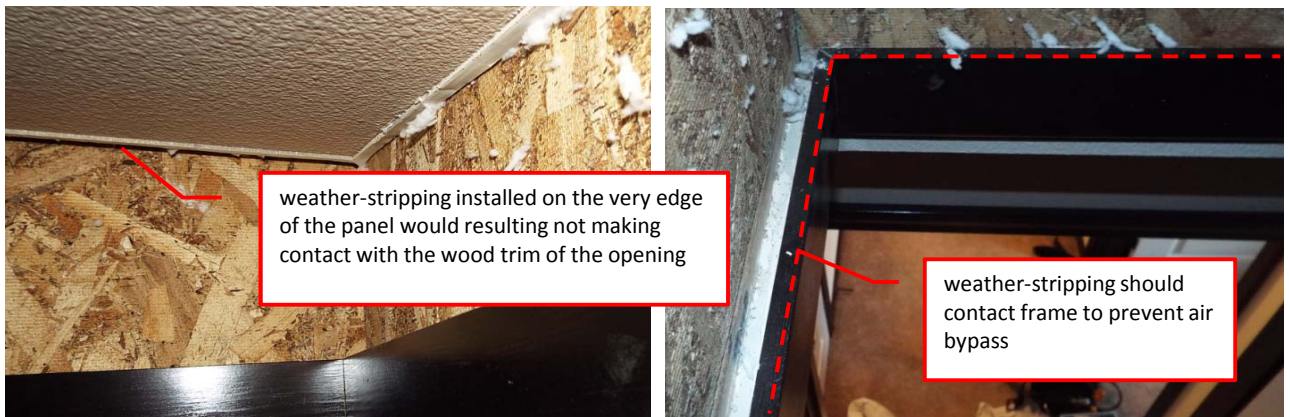
The attic access cover is not "properly" weather-stripped and can allow for heat /moisture from the living space to enter the attic. This is a common defect where the weather-stripping is installed prior to installation of the decorative trim around the inside of the opening. Because the trim sits inside the weather-stripping there is no contact with the weather-stripping. I recommend for energy conservation that proper insulation and weather-stripping be installed by qualified repair person.

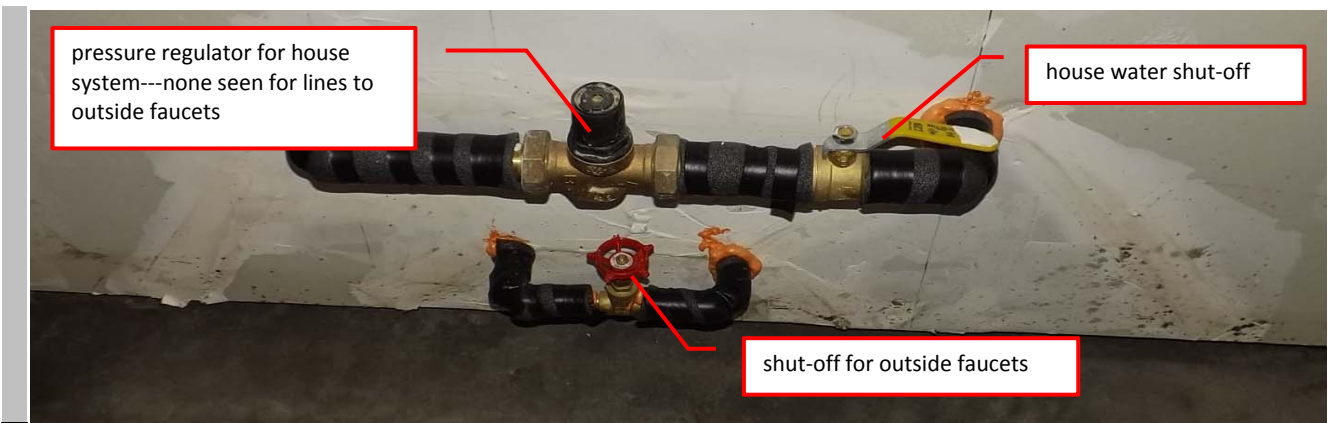
At 96 psi I recommend installation of a pressure reducing valve by licensed plumber for the water supply to the outside faucets.

Pressures this high can be very damaging to the electronic valves and pipe fittings/shut-offs.

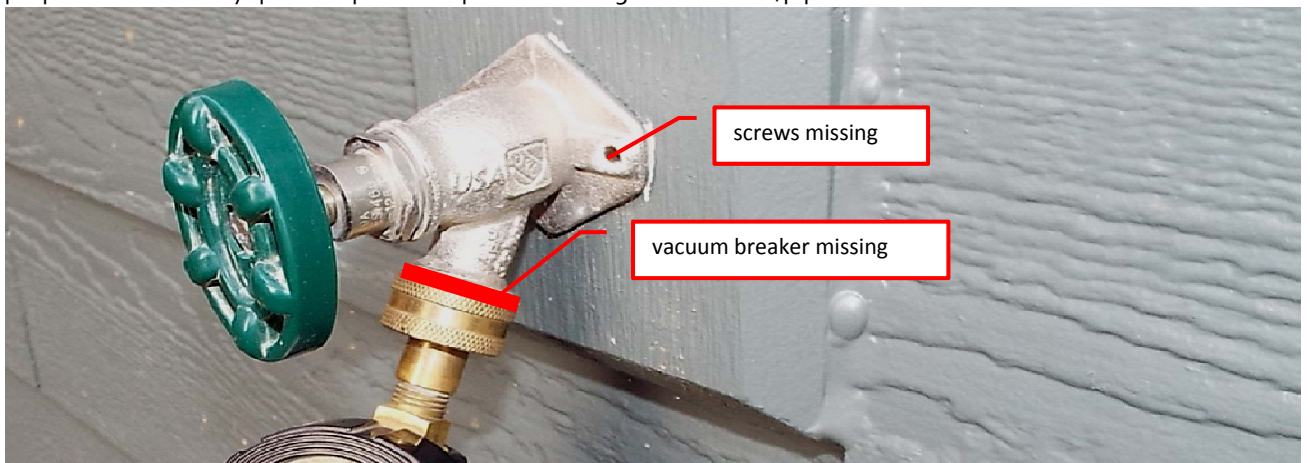
Anti-siphon devices on the two frost free faucets are missing. These devices are required by current regulations. Small amounts of water can remain in the anti-siphon device that can freeze in winter and cause damage to the device. Inside the device, where the water comes out, there is a lever that needs to be moved to drain this small amount of water. This will help protect the device from freeze damage. I recommend bringing this to the attention of the builder for proper repairs.

The hose faucet at the SE corner of the home is not properly attached to the house (screws missing). I recommend proper attachment by qualified person to prevent damage to the valve/pipe connections.

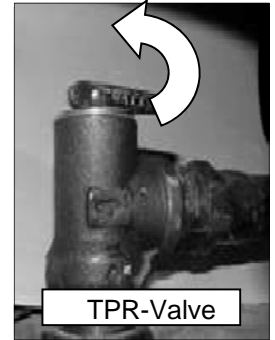
A temperature and pressure relief (TPR) valve is required on all water heaters to discharge any excessive pressure within the tank. A discharge pipe should be attached to the TPR valve and directed to a safe location away from body contact. Newer installations must be directed to the building exterior. Most manufacturers suggest that homeowners test the TPR valve at least once a year by lifting the lever to ensure the valve discharges properly. The picture to the right shows a typical top-of-tank type TPR Valve. They may also be found on the side of the heater on some models. This inspector does not test these valves due to the possibility that they may leak after testing. A leaking or inoperative TPR Valve should be replaced immediately by a licensed plumber.

Typically a maximum of 4, 90 degree bends are allowed in the drain of the TPRV of the water heater--per valve manufacturer and water heater manufacturer recommendations. There are currently at least 6. Unless a way of terminating the drain to the exterior can be achieved with four or less elbows I recommend that it be properly terminated elsewhere. I recommend evaluation/repairs by a licensed plumber and/or bring to the attention of the builder/seller for proper repairs.

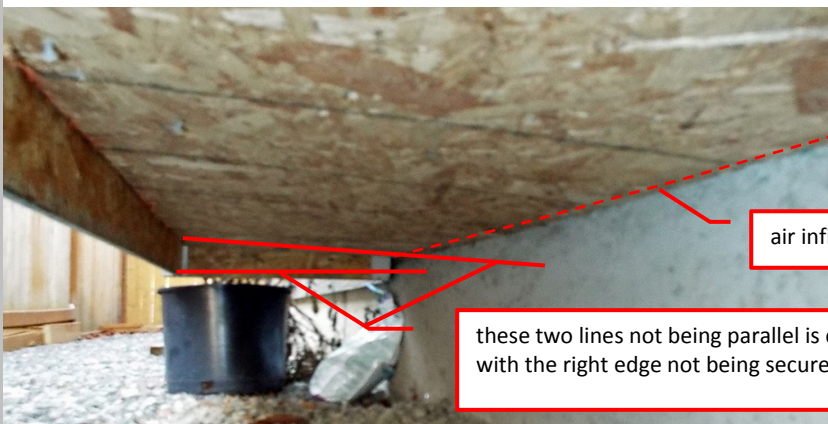
Considerable amount of cold air was noted coming into the home at the floor near the West corner of the fireplace. This is likely due to improperly secured soffit board on the underside of the fireplace that extends past the foundation and possibly due to missing insulation in this overhanging floor structure. I recommend further evaluation to verify that the floor is insulated and the bottom board is properly attached and weather-proofed.

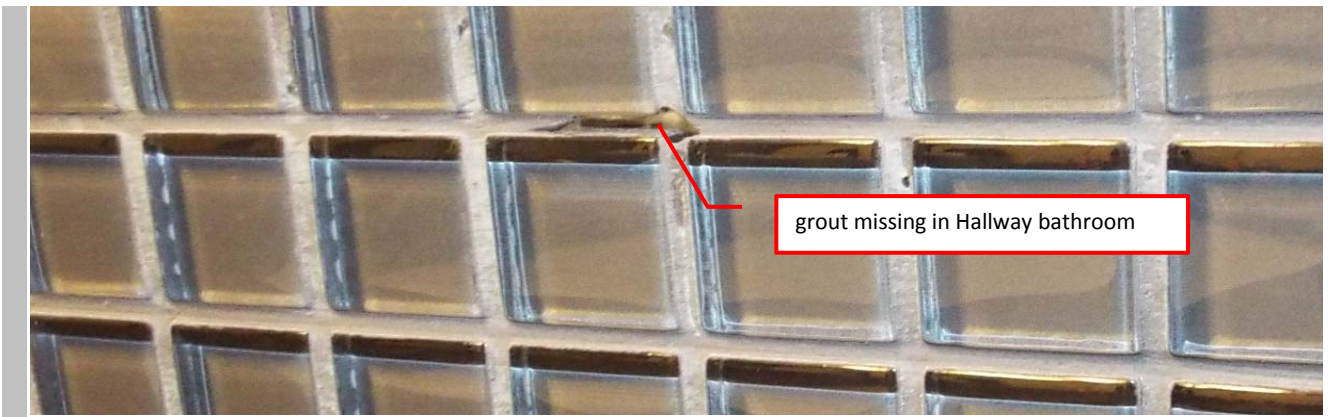
Some of the tile backsplash grout is not professionally completed. I recommend careful evaluation of all of the tiled areas by a qualified party to properly complete the grouting.

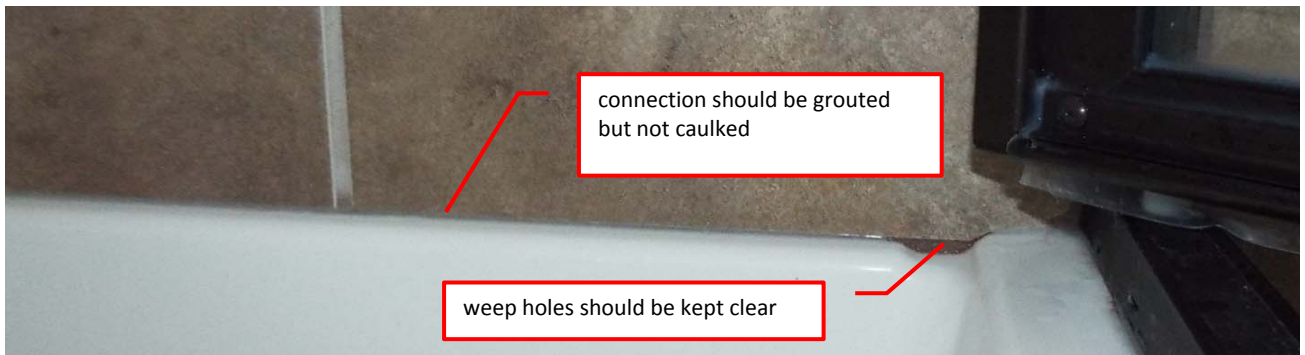
The grout around the base of the shower has been caulked over. Caulking this connection can result in trapping of moisture behind the tiles/caulk resulting in mold growth behind the caulk. There are weep holes at both sides of the shower that should remain open to allow a path for moisture to escape that finds its way behind the tiles at the shower base. This connection should either be grouted only or caulked only----but not both. I recommend proper repairs of this connection by a qualified tile installation company.

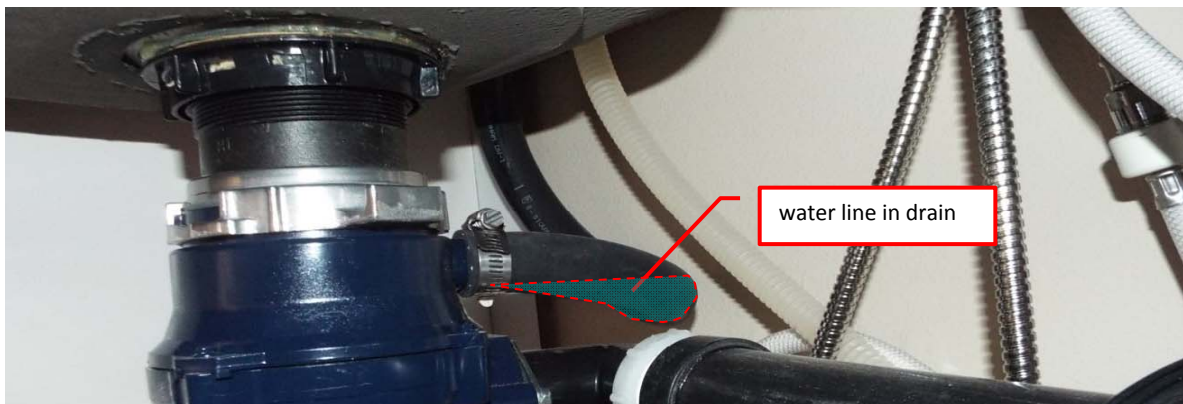
The dishwasher drain from the Air Gap device to the disposer traps water in it. I recommend a qualified party shorten the hose enough that water won't stand in the pipe which can lead to clogging of the drain.
