CHARLES BUELL INSPECTIONS, Inc.

# BUILDING INSPECTION REPORT

Main Street, Somewhere, WA

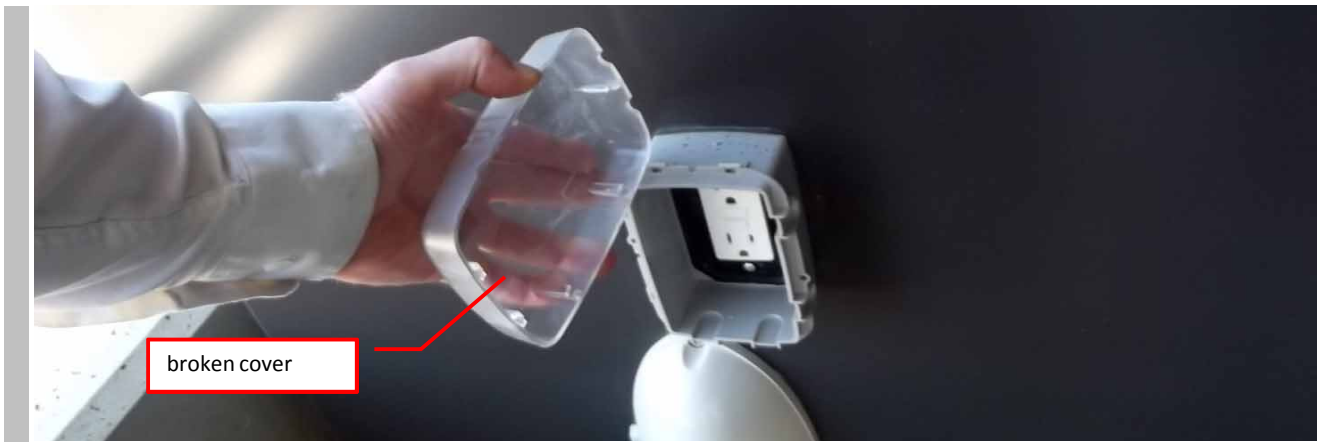
The cover for the outdoor GFCI receptacle on the deck has a broken cover. I recommend proper repairs/replacement by the licensed electrical contractor or other qualified person.

- #3** The cover for the outdoor GFCI receptacle on the deck has a broken cover. I recommend proper repairs/replacement by the licensed electrical contractor or other qualified person.

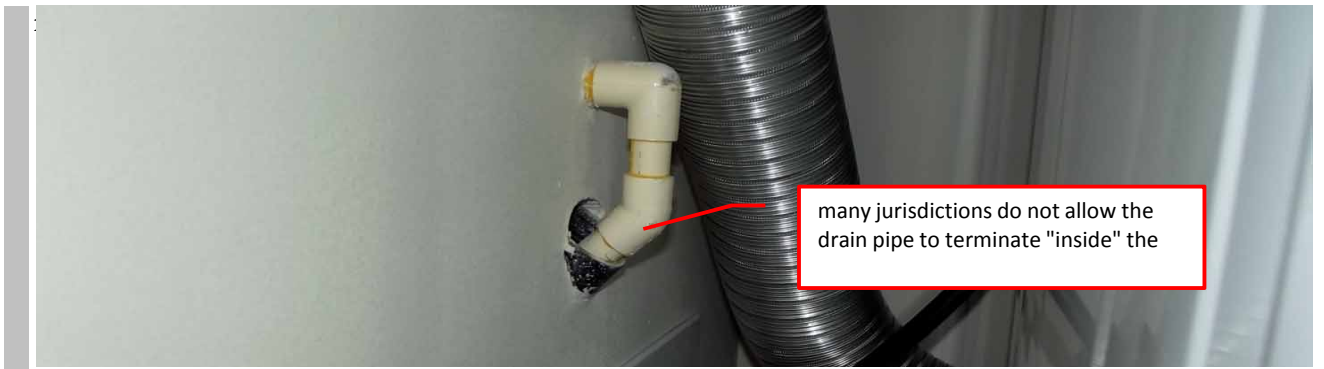
One of the requirements of the drain from the pan under the HVAC is that it be installed in a manner such that it can be monitored for leaking. I do not know if the drain visible next to the washer/dryer is the secondary drain from the pan or whether it is the condensate drain from the HVAC unit itself. I recommend consulting with the builder/seller as to the function of this drain and verify that it is installed properly.

**#5** One of the requirements of the drain from the pan under the HVAC is that it be installed in a manner such that it can be monitored for leaking. I do not know if the drain visible next to the washer/dryer is the secondary drain from the pan or whether it is the condensate drain from the HVAC unit itself. I recommend consulting with the builder/seller as to the function of this drain and verify that it is installed properly.

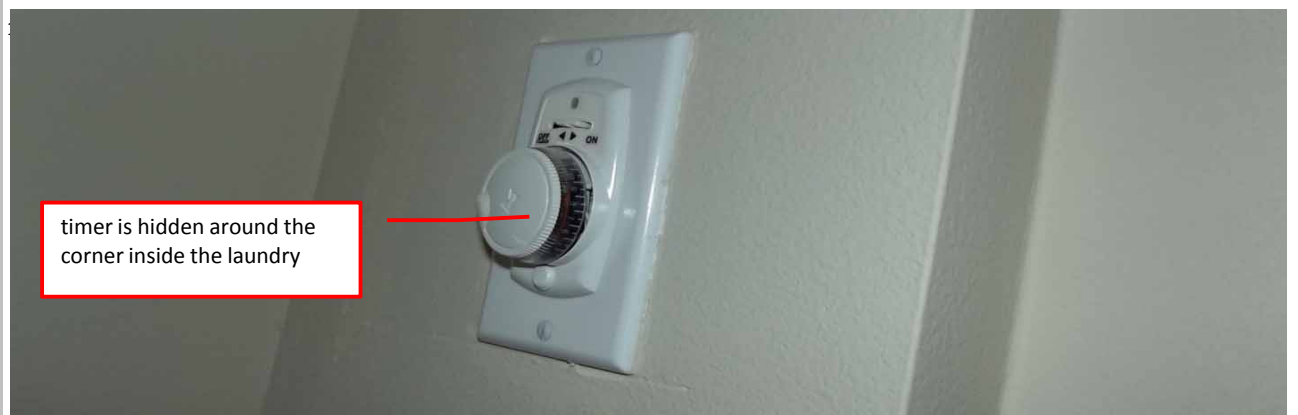
The timer control for the whole house ventilation fan is in a very difficult location for proper setting and maintenance of the timer. Consult with builder/seller as to possible alternatives to the current installation. Relocation is recommended.

**#6** The timer control for the whole house ventilation fan is in a very difficult location for proper setting and maintenance of the timer. Consult with builder/seller as to possible alternatives to the current installation. Relocation is recommended.

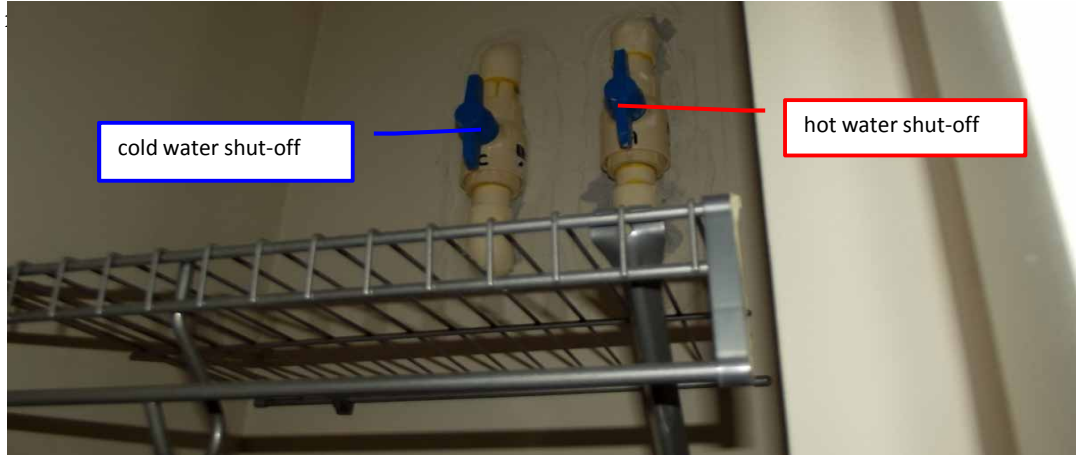
The water shut-offs for the unit are located above the shelf in the Laundry---above the timer for the whole house ventilation fan.

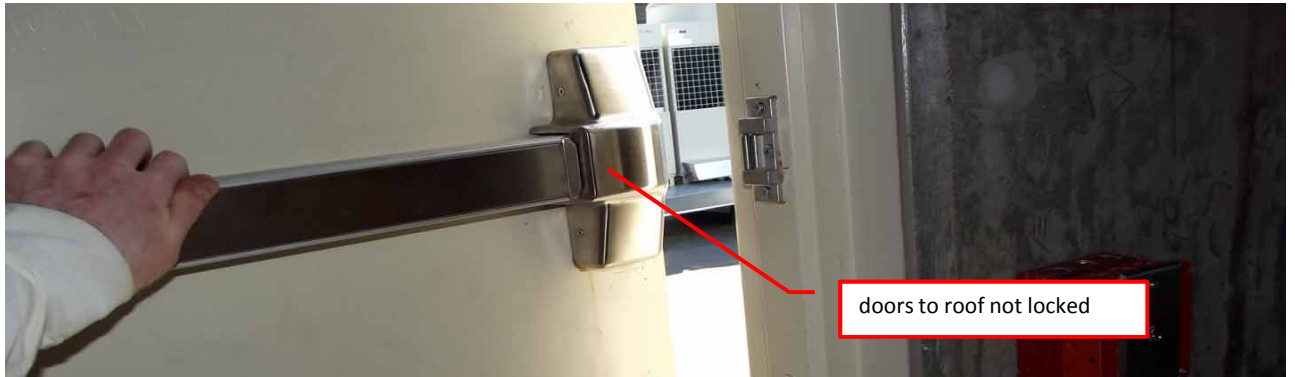
It was noted that at the top of the stairwell that there are two service doors that lead to the roof that have emergency egress type locksets installed. These may be required on these doors but if they are there are no barriers to falls from the roof. I recommend discussing this with the builder/seller and/or discussing with the Condo Association as to the appropriateness of the current installation.

**#7** It was noted that at the top of the stairwell that there are two service doors that lead to the roof that have emergency egress type locksets installed. These may be required on these doors but if they are there are no barriers to falls from the roof. I recommend discussing this with the builder/seller and/or discussing with the Condo Association as to the appropriateness of the current installation.

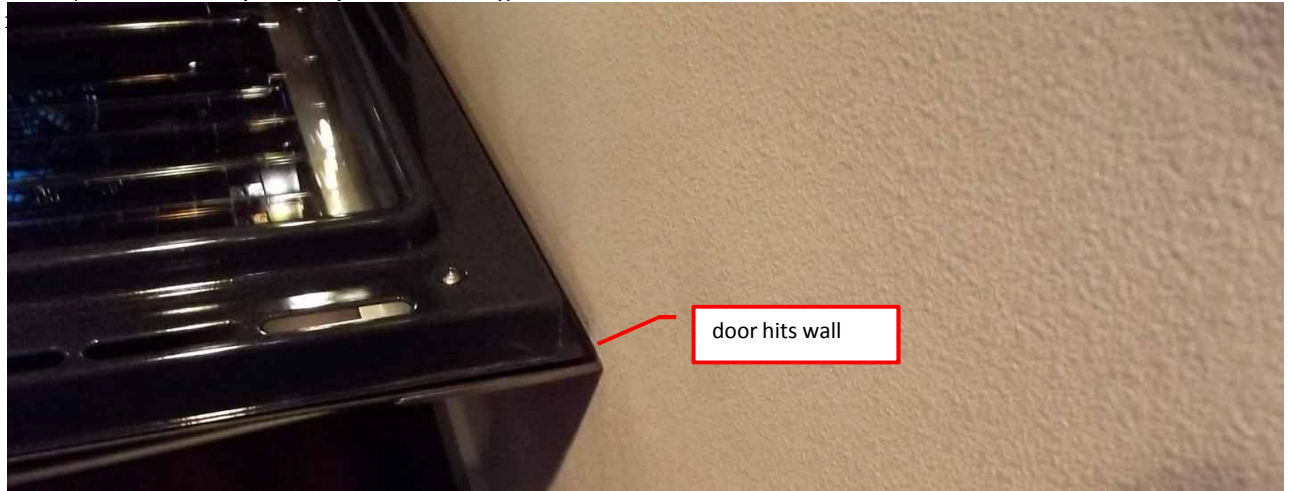
The Oven door hits the wall when opened. I recommend bringing this to the attention of the builder/seller for adjustments adequate to prevent damage to the wall.

**#10** The Oven door hits the wall when opened. I recommend bringing this to the attention of the builder/seller for adjustments adequate to prevent damage to the wall.
